TITLE: Design 2	
Document Number:	REV:
Date: 6/18/2007 05:47:19p	Sheet: 1/1

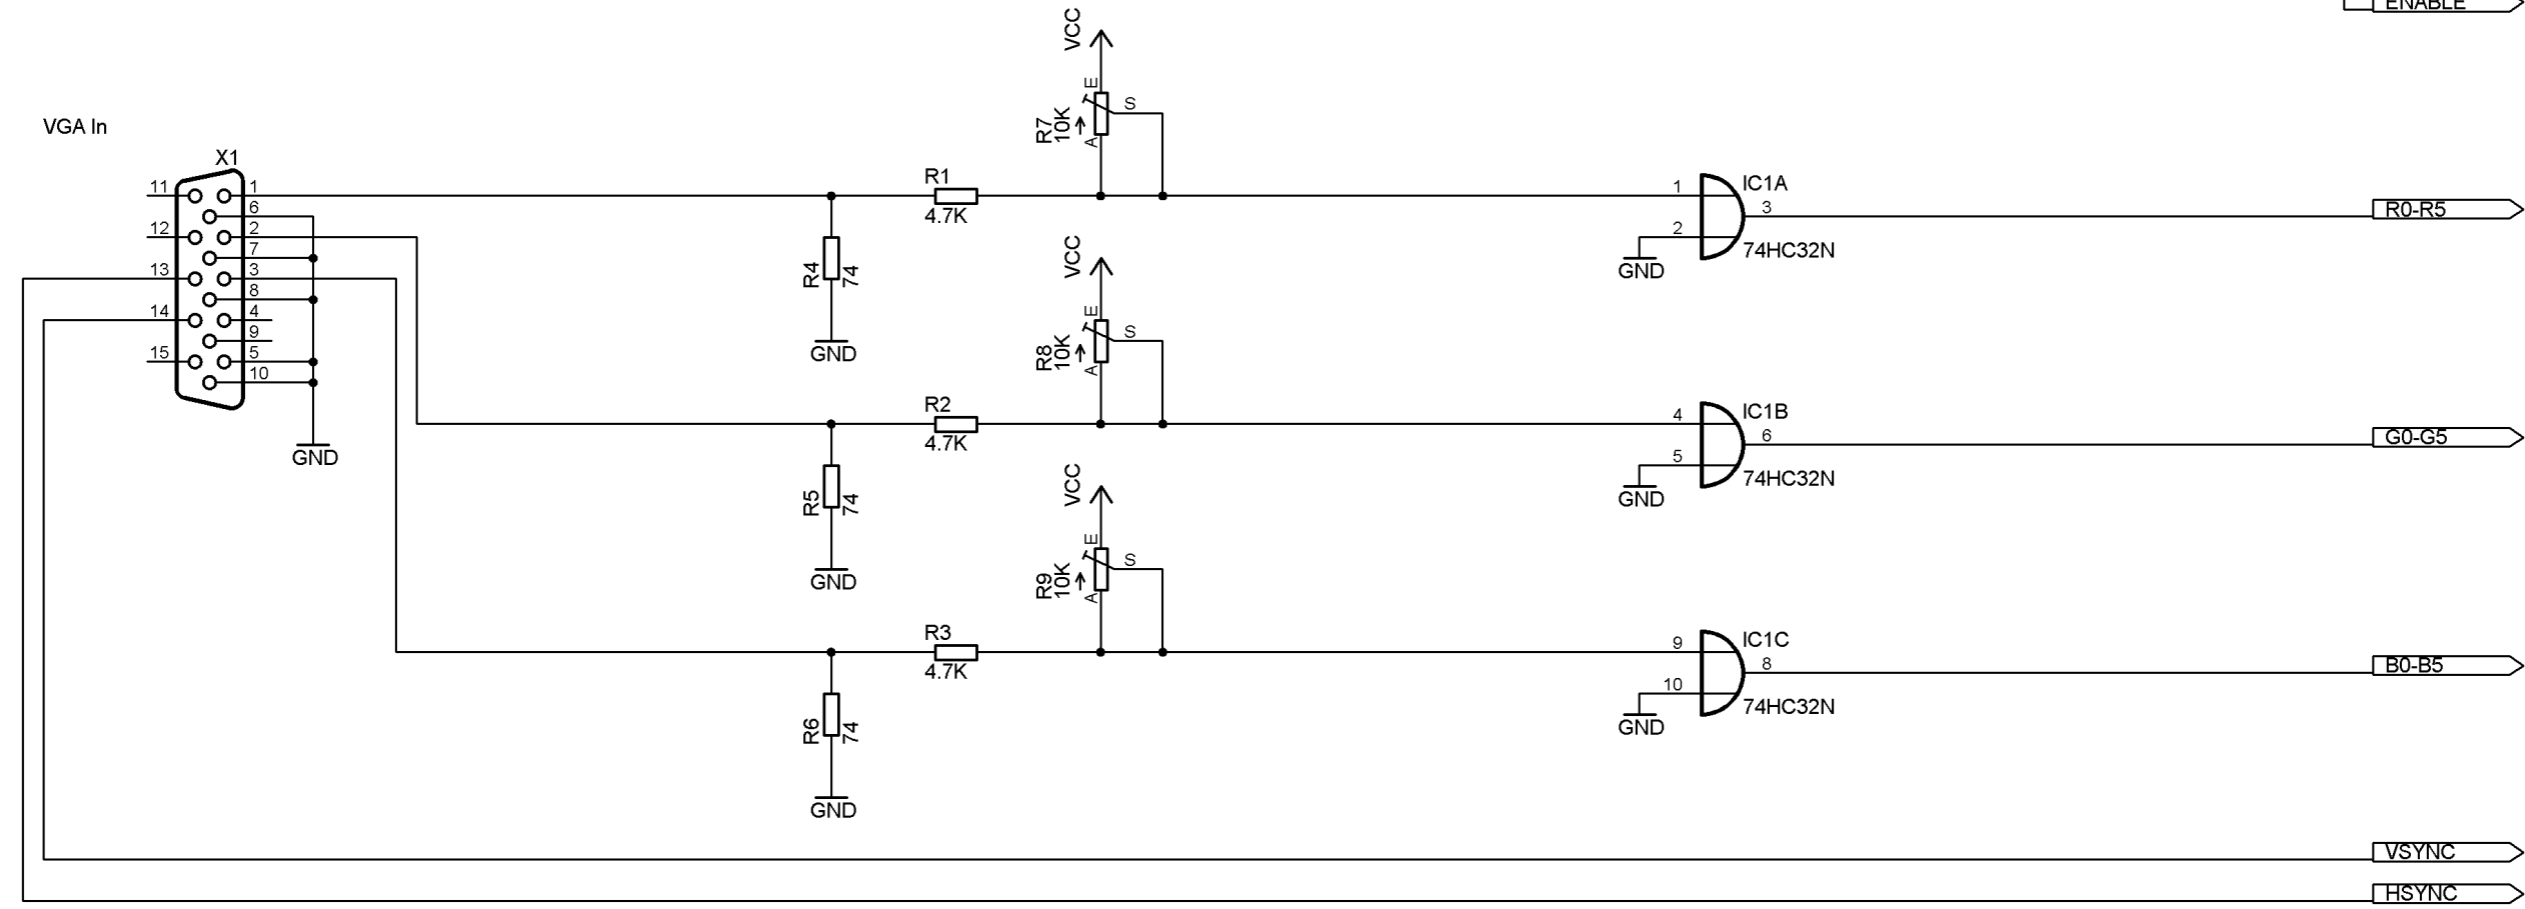
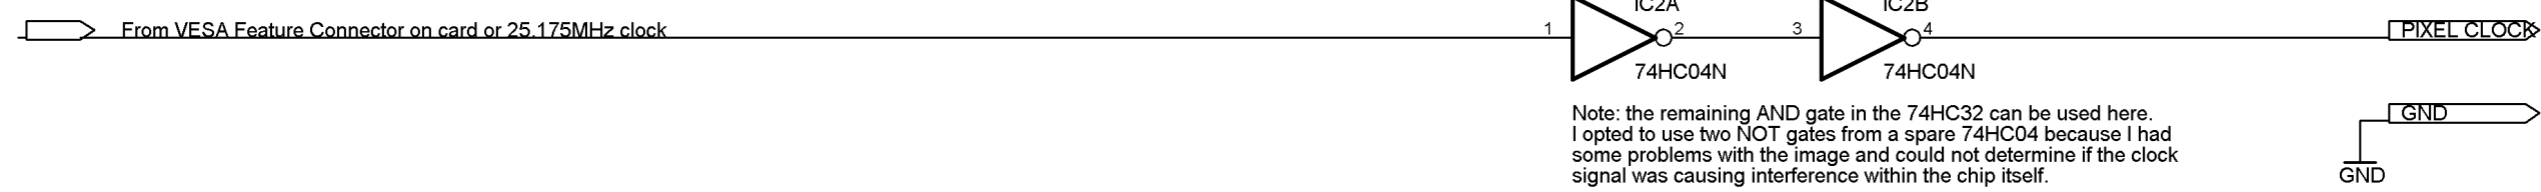
Note: the remaining AND gate in the 74HC32 can be used here. I opted to use two NOT gates from a spare 74HC04 because I had some problems with the image and could not determine if the clock signal was causing interference within the chip itself.
